Vortex

Slimline Concealed Cistern

with Air Gap Technology

VOR790

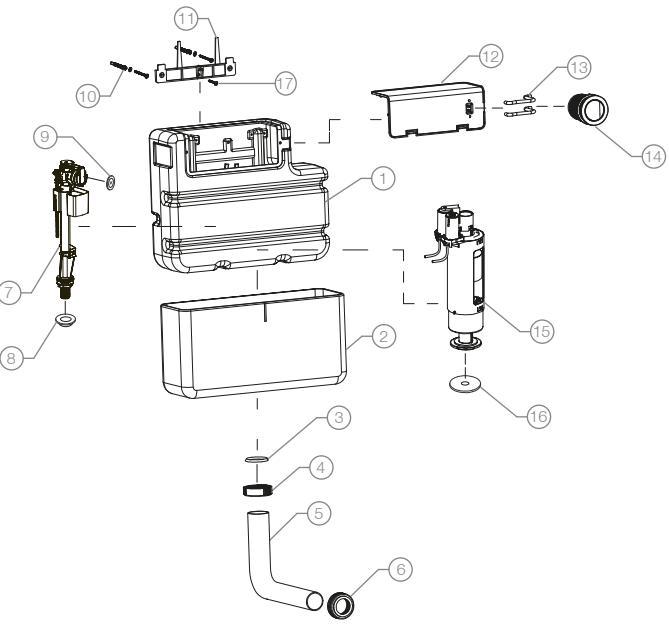
Parts included

- I. Cistern
- 2. EPS Jacket
- 3. Seal SP12168
- 4. Flush Bend Nut SP12168
- 5. Flush Bend SP12167
- 6. Pan Seal Cone SP12170
- 7. Bottom Entry Fill Valve SP19745
- 8. Stem Sealing Washer SP19757
- 9. Inlet Valve Diaphragm SP19756
- 10. 2 × Attaching Screws SP12163
- II. Attachment Plate SPI2I63
- 12. Cistern Cover SP12164
- 13. Air Hoses SP17421
- 14. Pneumatic Push-button SP12169
- 15. Flush Valve SP12166
- 16. Flush Valve Flapper Seal SP12551
- 17. Cistern Fixing Screw SP12163

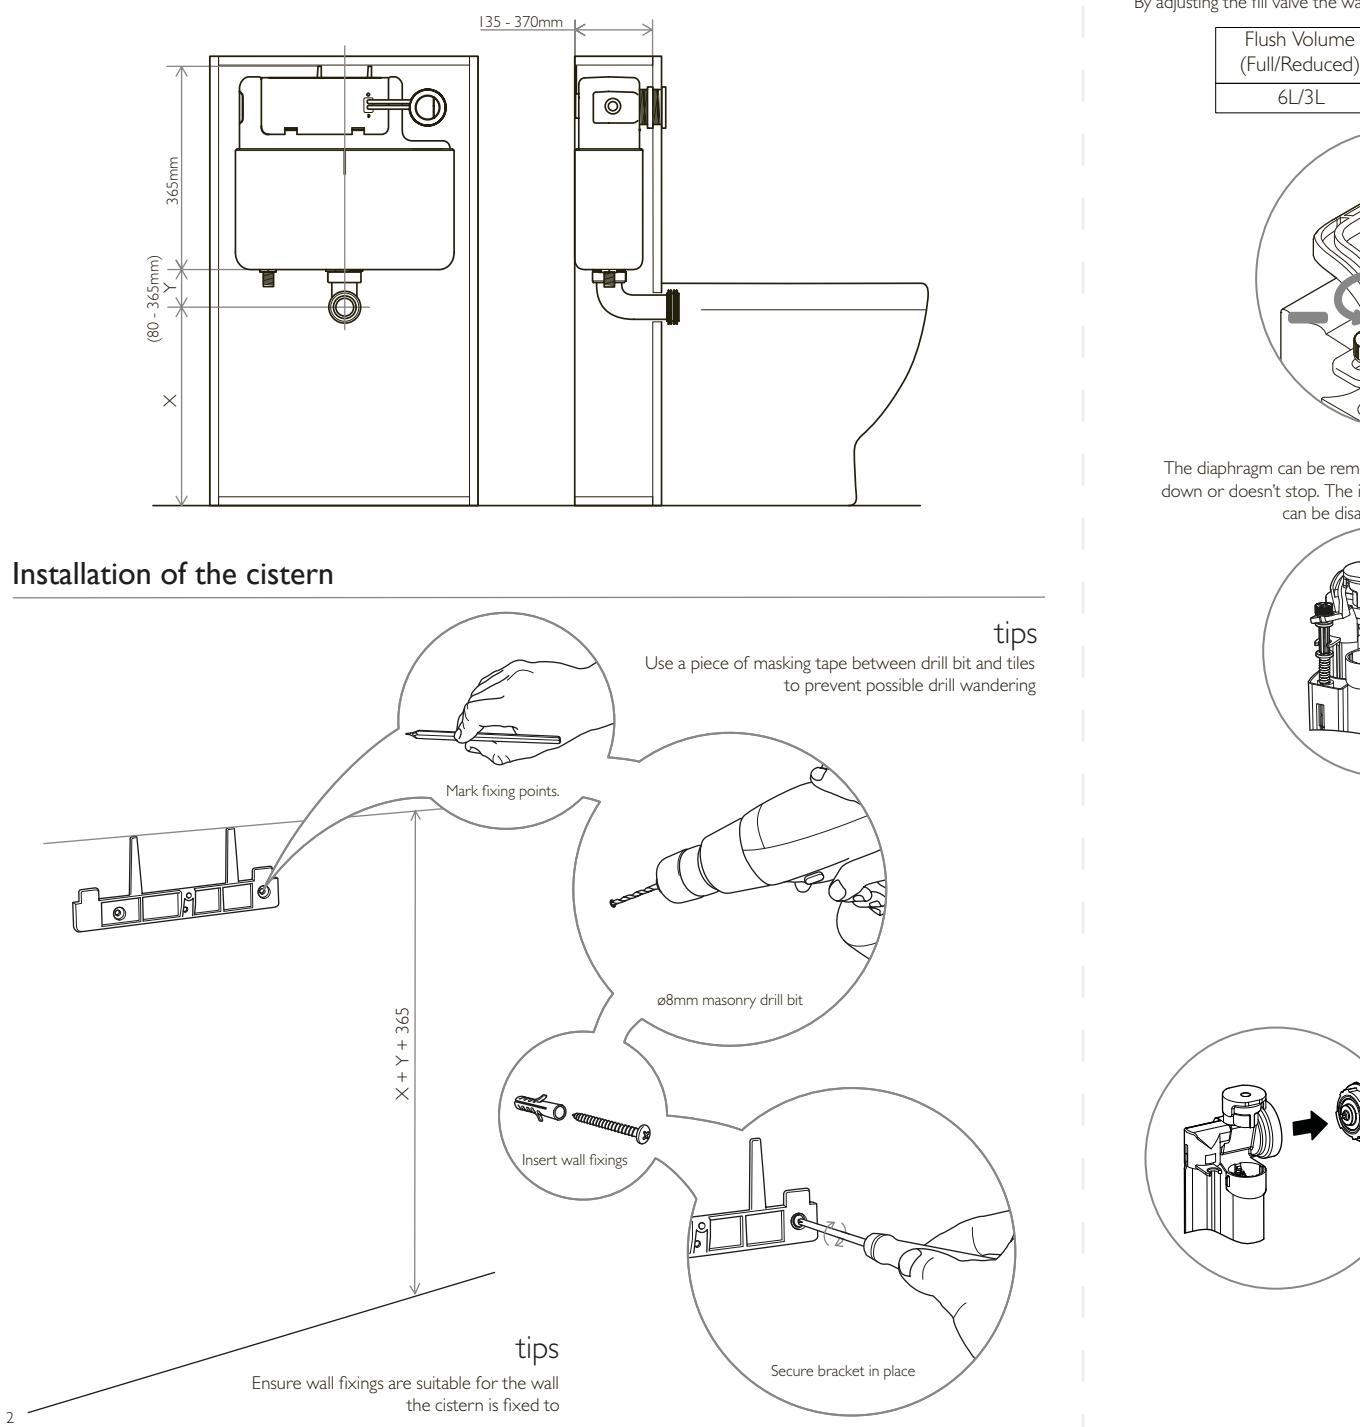
Inlet Valve Adjustments and Maintenance

By adjusting the fill valve the water level can either be increased or decreased accordingly

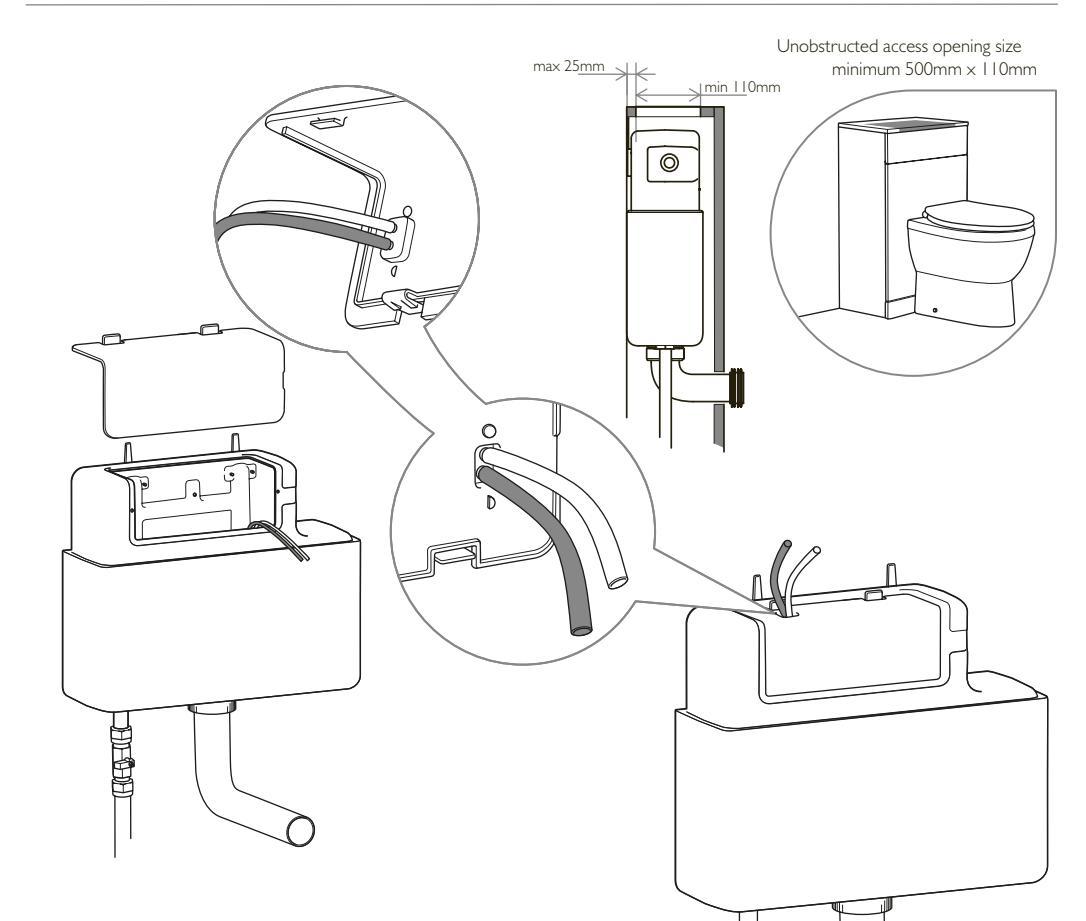
Installation with a top access panel

note Check valve not included

Connect the water supply to the cistern using an approved double check valve to fluid category 3 in addition to an accessible service or isolation valve.

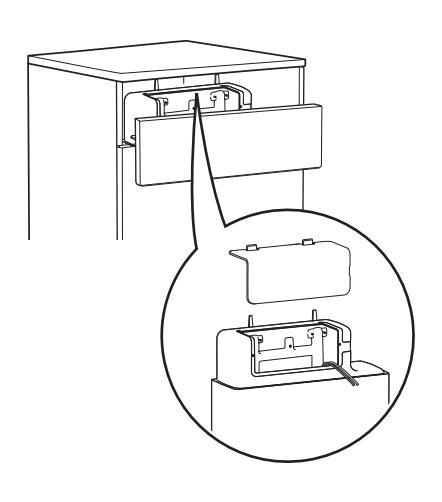
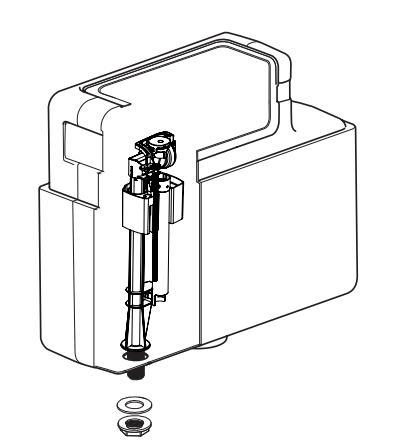
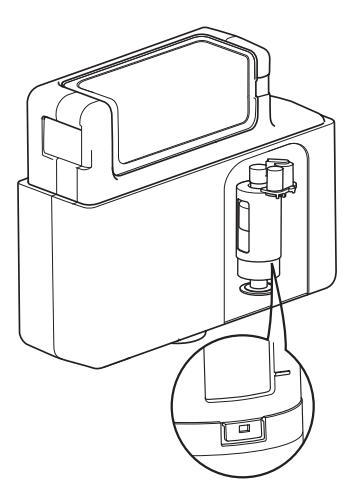
How to Access your cistern

- 1. Remove fascia panel
- 2. Remove the blue cover on the cistern
- Shut off Water Supply
 Unscrew the nut from the flexible hose
 Pull out the fill valve
- 1. Gently twist & remove flush valve (anti-clockwise)

Problem	Potential cause	Suggested action
The Fill Valve does not work or isn't controlling the water supply efficiently.	The inlet valve may be blocked.	Follow the instructions below and clean the water inlet orifice, diaphragm and cap. If split or scaled up, replace the diaphragm, available as SP19756. 1 1 1 1 1 1 1 1 1 1 1 1 1 1 1 1 1 1 1
Water leaks from the base.	1 The flush valve stem may be obstructed or jammed, preventing it from falling back into position.	Ensure that there is nothing obstructing the flush valve and the stem can extend up and down.

Potential cause	Suggested action
2 The rubber flapper seal may have fallen off, may need cleaning or could be damaged.	Ensure the flapper seal is fixed in position. However, If it's damaged a replacement is needed, this is available as SP12551.
	NOTE: Before re-fitting the flush valve assembly check the base is correctly seated as shown to the left and not out of position (see below as an example)
	Ensure the rotation of the blue, reduced flush float is in the correct position, and has locked in place securely. If it isn't (as shown left) the float can catch on the adjustment measure. To lock in place, simply rotate the float anticlockwise.
The pneumatic tubes may be pinched or may have been installed incorrectly.	The blue tube must be connected to the joint marked with a half circle, The transparent tube should be connected with the joint marked with a full circle. Ensure the same configuration is used on the flush button
